## MP-03 : SERVICE FACTOR INFLUENCE ON THE OVERLOAD CURVE

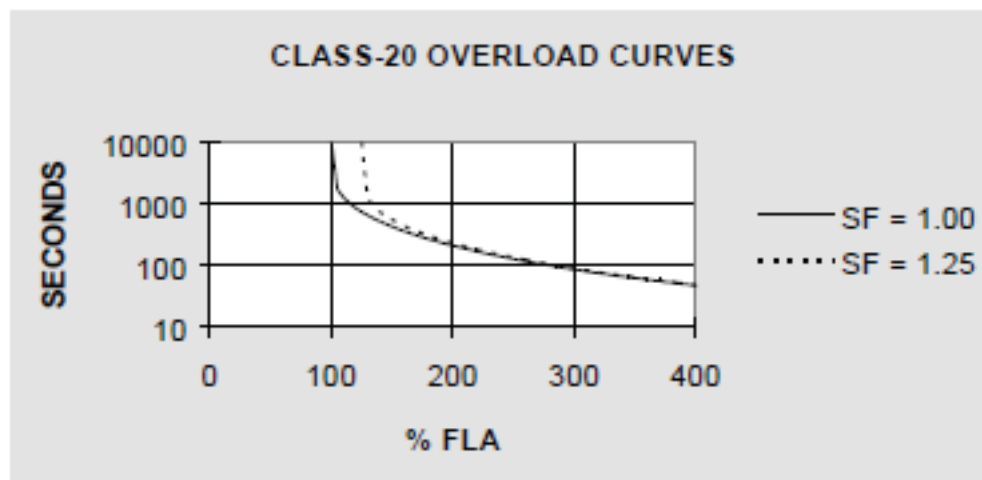
With respect to the MPU-32 and MPS, time-to-trip at 600% FLA is the default overload class. Overload class is derived from the motor's allowable locked-rotor time which is related to the thermal capacity of the motor. It is possible to program the overload class to represent time-to-trip at other percentages of FLA as well. It is the percent of full-load current that will ultimately cause temperature rise and the relay to trip. Service factor is related to a motor's thermal resistance—a measure of its ability to get rid of heat. The product of thermal capacitance and thermal resistance is a thermal time constant. Increasing the service factor decreases the ultimate temperature rise at any current and the time constant in the thermal model. The resulting time-to-trip will be increased for all values of current. Minimum and maximum service-factor curves for a class-20 overload show that time-to-trip during starting is unaffected by service factor—its effect is significant only for overloads less than 200% FLA.
